Project Title: Local Manufacture of AID Handpump and Robo Devices in Tunisia

Project No: A-2748

**AID HAND-OPERATED WATER PUMP
SHALLOW WELL**

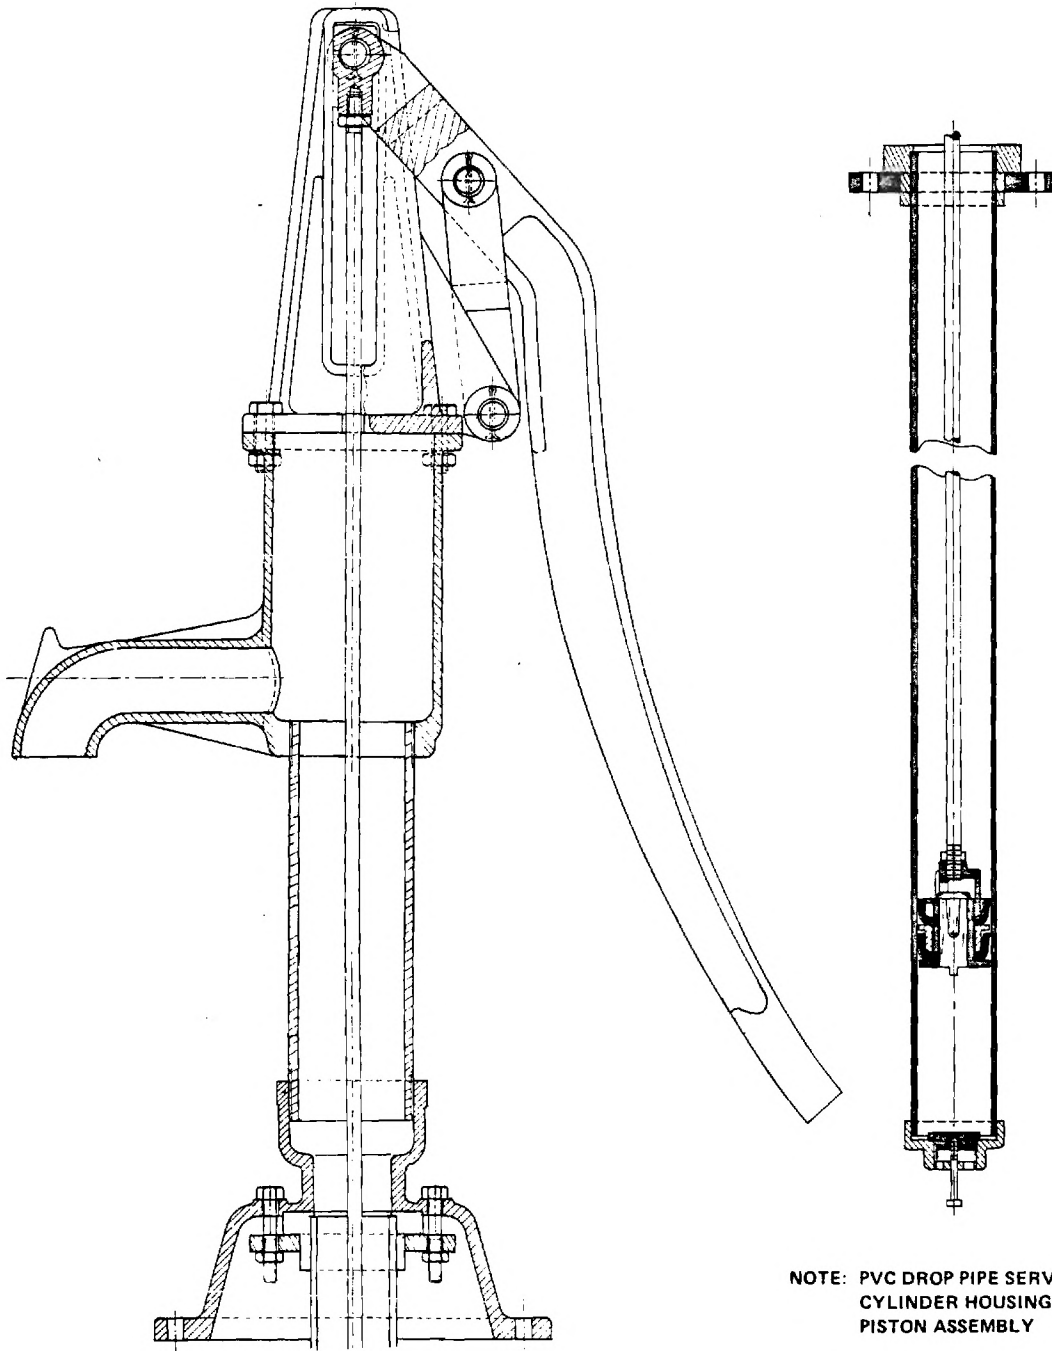
Figure 3

**AID HAND-OPERATED WATER PUMP, DROP PIPE AND PISTON
ASSEMBLY MANUFACTURED IN TUNISIA**

was corrected by the foundry machining down the outside diameter dimensions of the piston assembly components and by reducing the size, or outside diameter, of the leather cups from 55 mm to 50 mm). Some pumps had a loose connection where the pump body screws into the pump stand which had to be better tightened and sealed. One pump had a small pinhole in the pump stand casting. Pump caps had bolt holes drilled too close to the piston rod guide section of the pump cap which made securing of the cap to the pump body difficult. The pumps were painted with a red paint which did not dry even after six or seven days (Fonderies Reunies reported that a drying agent was left out of the paint by its plant personnel). Lastly, foot valves leaked at an unacceptable rate, a matter that was eventually resolved by using foot valves commercially available in the United States. In addition, other pressing and unusual problems arose, the most critical being the shortage in-country of various materials and supplies such as leather cups, PVC pipe with a smooth inside surface, PVC pipe couplings and PVC cement. A source of supply was eventually found for these items, but they remained in short supply throughout the project.

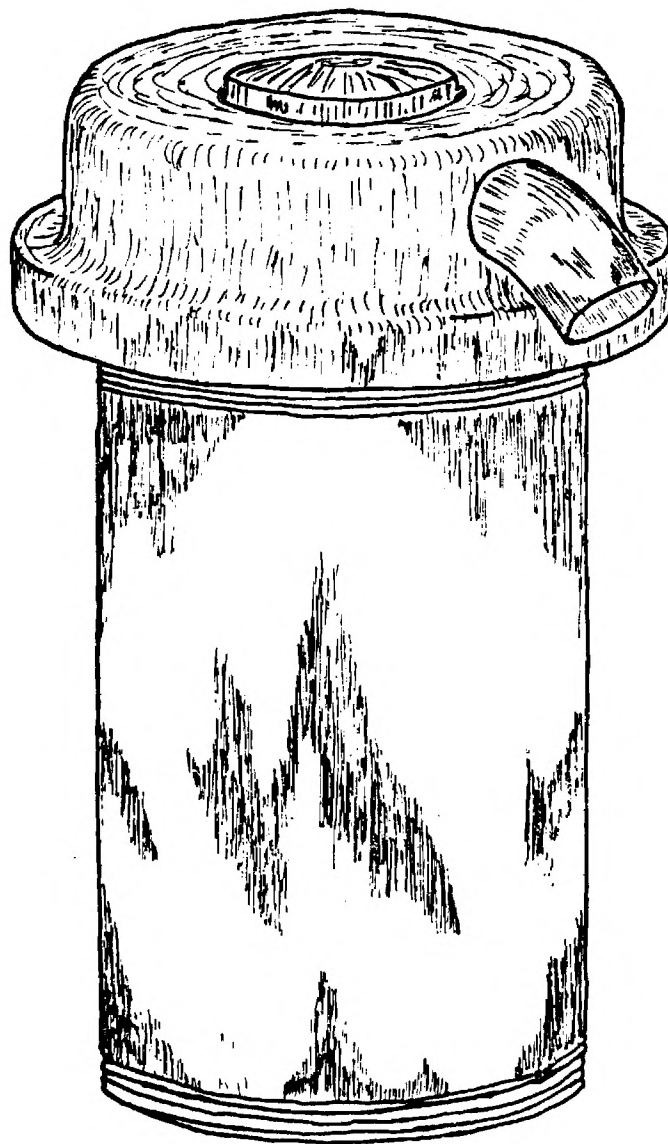
Figure 4 PUBLIC HYDRANT ROBOVALVE

A public hydrant robovalve model (see Figure 4) was installed by CARE at a capped spring in the Siliana governorate, but it was not well received by the users. The major complaint about the robovalve was its major feature, that of being self-closing. Because rural Tunisians use containers holding as much as 10-15 gallons of water, they found it very time consuming to hold the button/float valve in a downward position while the container was being filled and resorted to weighting the button down with a rock. After some time the rocks eventually wore the button off.

A public hydrant model also was installed by Genie Rural engineers at a capped spring near Bizerte. The spout on this valve broke off soon after installation which rendered the valve useless.

In light of the above experiences, it was decided not to initiate the manufacture of the roboscreen and robovalve in Tunisia. There was no market for the roboscreen, and the robovalve, being self-closing, appeared to be culturally unacceptable. Also, it was determined that the molds alone for the robovalve would cost approximately \$13,000. This was considered a prohibitively high figure especially in the absence of a market that would allow the amortization of this cost over thousands of units of production.

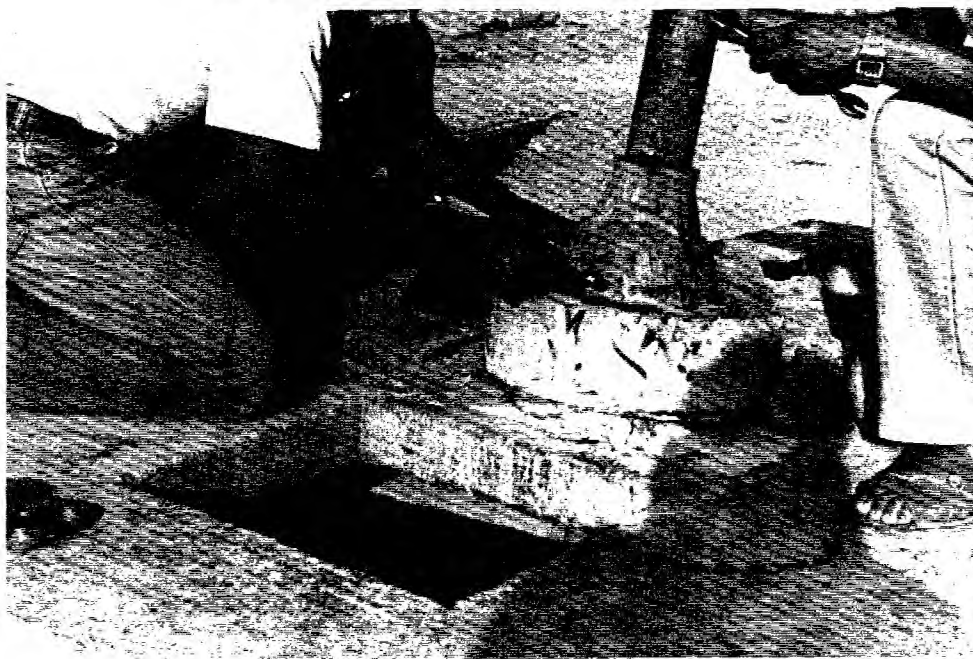
Figure 7

Site No. 6(Belhijette/Kasserine)where loose anchor bolts, a badly broken pedestal and a missing access hatch were found during fourth and final field trip to Tunisia.

The pedestal at site 6 appeared to have been broken up with a sledgehammer. The pump at site 7 appeared to have been deliberately broken, as breaking of the pump in the threaded area of the galvanized iron pipe would have taken a tremendous effort. Thus, the AID handpumps seemed to have suffered the same fate as those installed by CARE. CARE representatives reported only days before the above inspection that they had just abandoned a site after five handpumps at that site had apparently been deliberately broken. Springs capped by CARE also had the access hatches repeatedly removed to allow access with a rope and bucket.

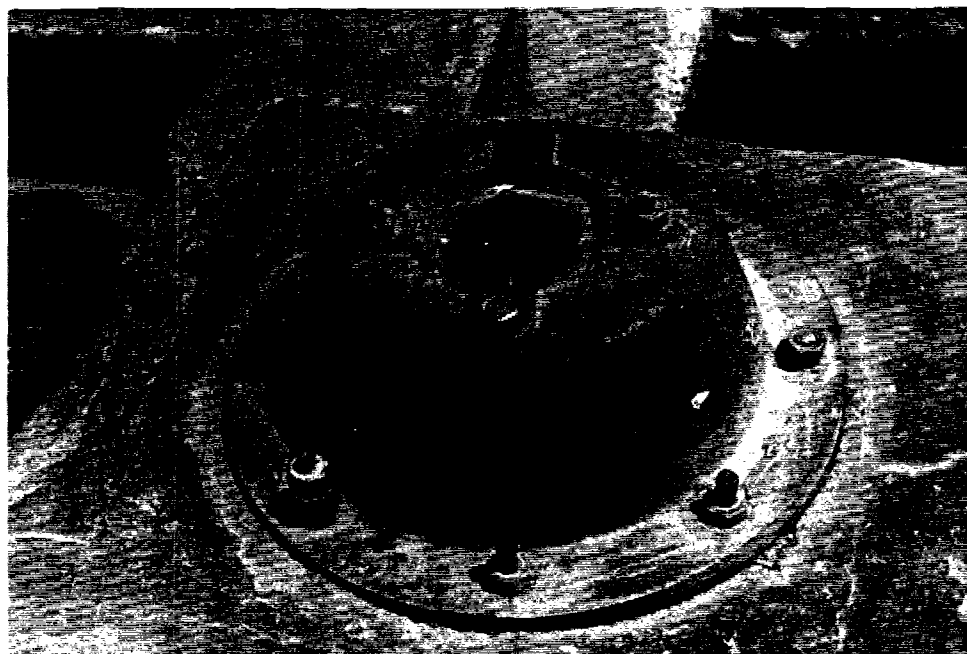
Figure 9

Site No. 9(Mlaz/Kasserine) where pump with original design base was found to be broken off at base and missing during fourth and final field trip to Tunisia. Access hatch also was missing.

<u>Site Number</u>	<u>Pump Functioning</u>	<u>Comments</u>
3	No	Handle gone from pump.
4A	No	It appeared that the plunger rod on piston assembly was disconnected.
4B	No	Pump broken at base (original design)(see Figure 6).
5	Yes	None
6	Yes	Pedestal that pump sits on broken up badly (see Figure 7).
7	No	Upper portion of pump broken off from 3" galvanized-iron pump body (see Figure 8).
8A	No	Pump broken at base (original design).
8B	No	Fulcrum pin missing, sliding block missing, rod end disconnected from plunger rod.
9	No	Pump broken at base (original design)(see Figure 9).
